# ROYAL COPENHAGEN GOLF CLUB IRRIGATION

## NOTES ON IRRIGATION VISIT w/c 29<sup>TH</sup> OCTOBER 2018

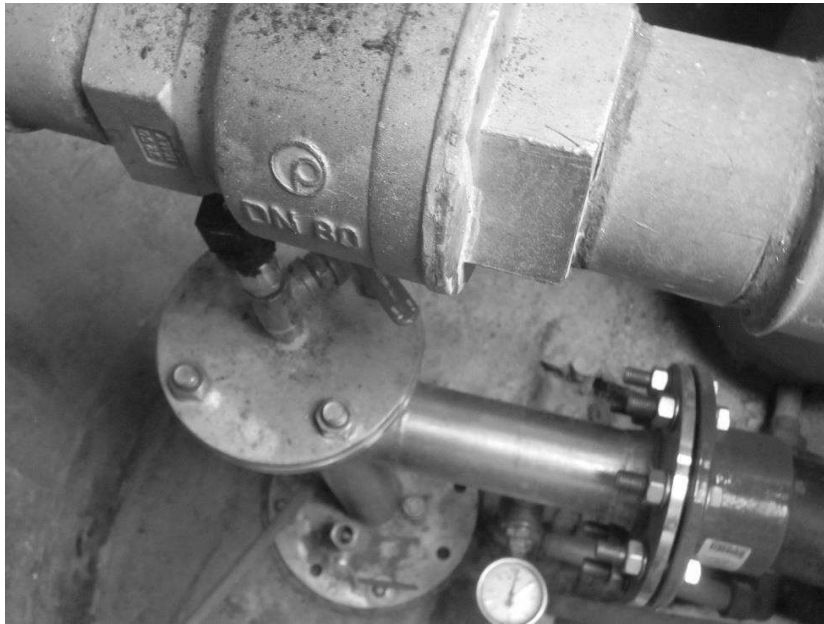
Irrigation borehole well head manifold [new]

**2.18**     The borehole well head arrangement varies in age. There has been a new pump installed and new stainless steel pipe work from the top of the well head [in 2018]. This is connected into the existing 3 inch delivery pipe work which connects to the golf course pipe work.

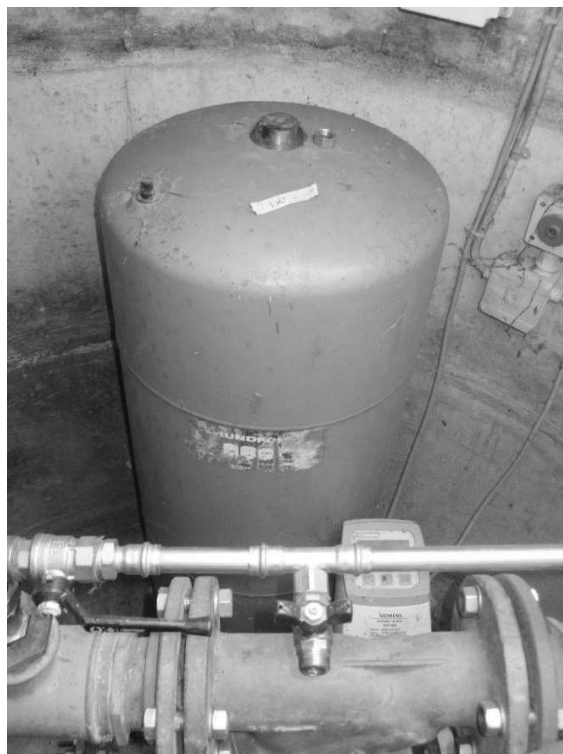
Pressure vessel in well head chamber [old]

**2.19**     Where the older well head infrastructure exists there is a need to have the pressure vessel examined and checked for safety (and then annually thereafter) [and replaced as necessary]. There is also a need to service/replace the Siemens Magflo [MAG500] meter so that water usage can be recorded.

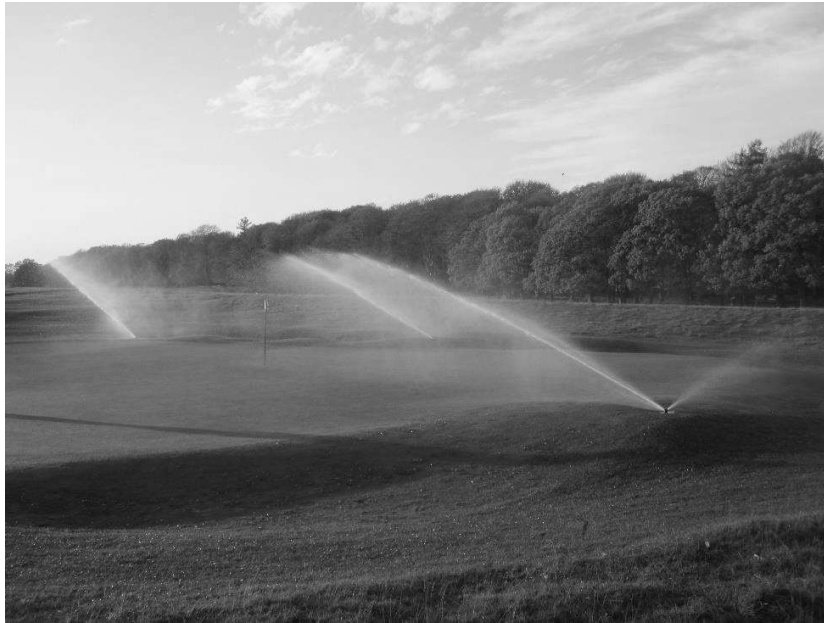
Green sprinklers in operation – note poor spacing and reduced pressure

- 2.48** In general the sprinkler spacing's on the greens were not uniform which makes accurate application of water (distribution uniformity) and calculation of sprinkler precipitation rate and run time calculations (scheduling) impossible. The Greenstaff are managing very well with the poor spacing, however, the poor spacing should be addressed particularly if green surround and approach irrigation is to be added.

- 2.50** In the future the sprinklers should either use a square or triangular configuration. Uniform spacing's are very important to ensure good water distribution to the surface and guarantee the minimum amount of water is required to successfully irrigate the surface.

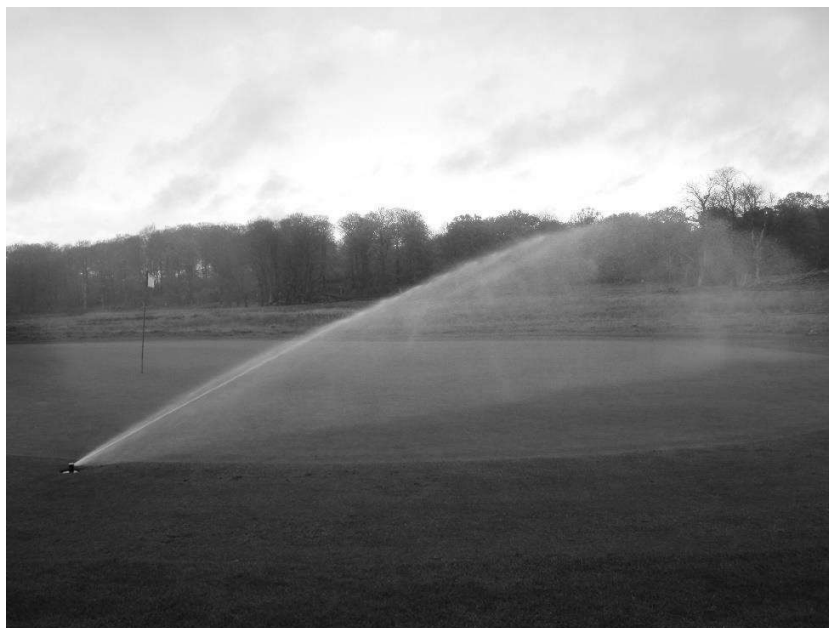
Green sprinkler in operation

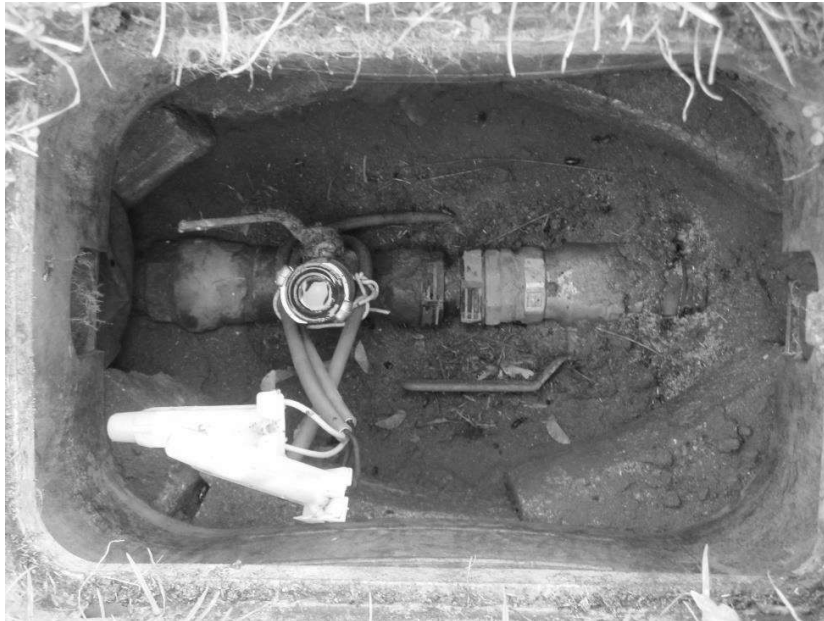
Green isolation valves  
Note; condition of handles and access to components  
(assemblies are certainly showing their 24+ years)

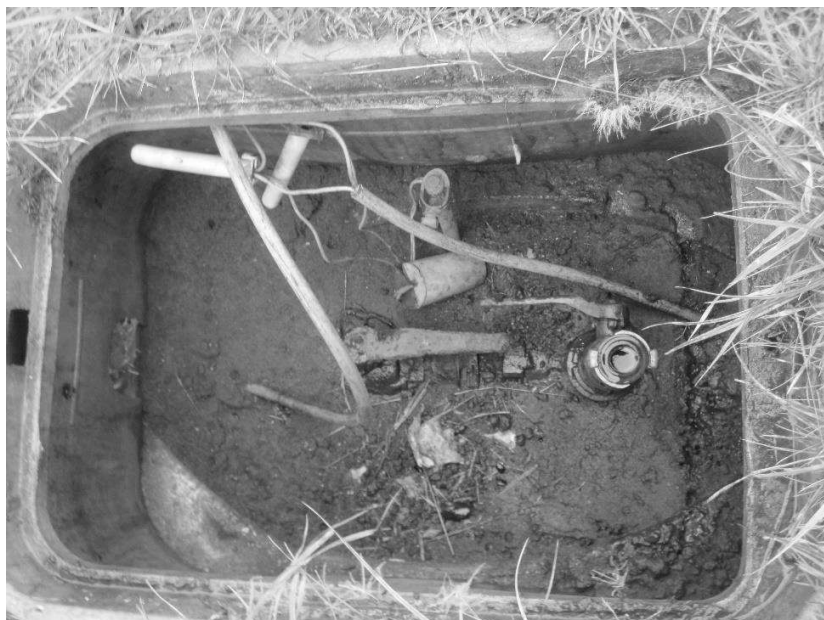
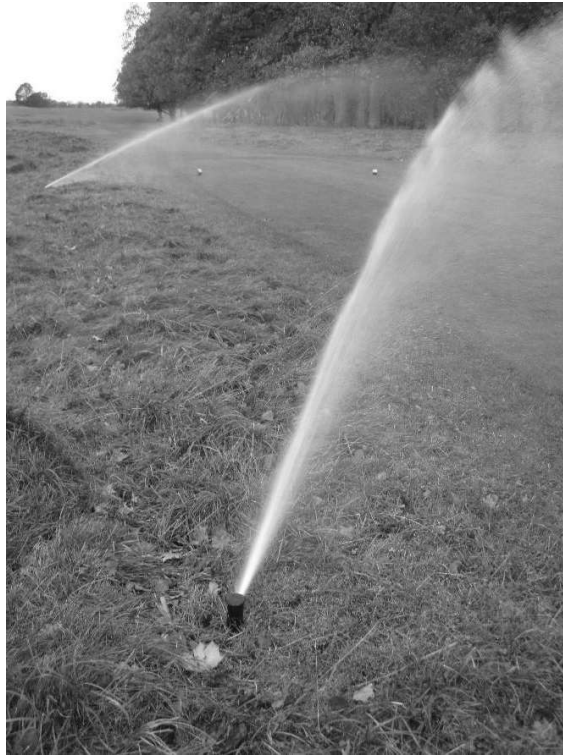
Tee sprinkler operation

Note; sprinklers too far off teeing surface, wasted water off teeing surfaces, poor coverage with sprinklers down one side etc

- 2.71** *In summary the tee irrigation needs to be replaced so that each tee within a tee complex can be separately irrigated ensuring that water can be targeted to where it is needed and water usage is efficient.*

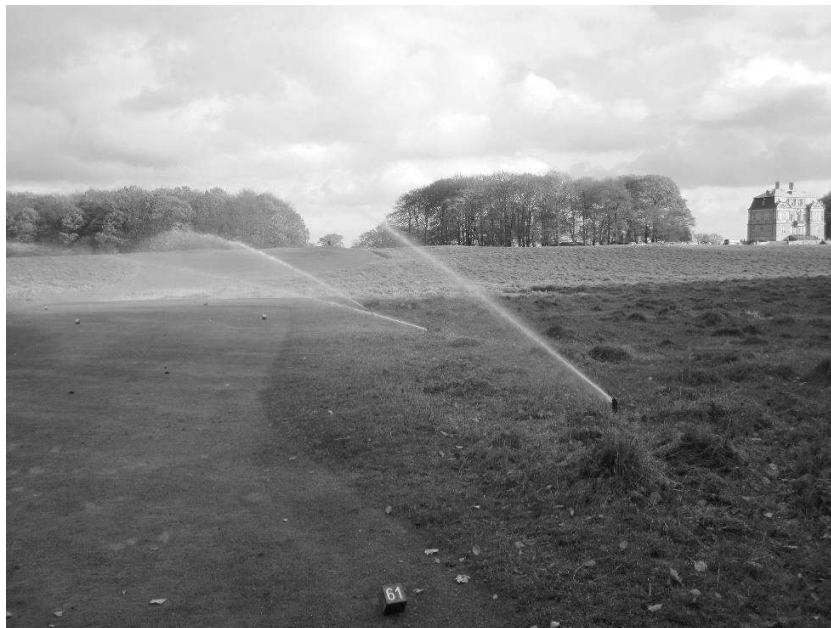
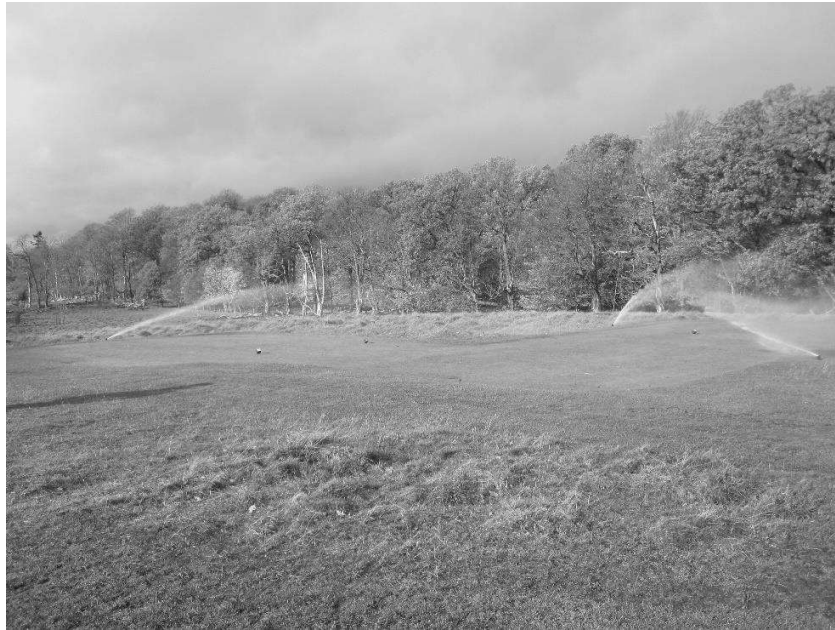
Tee sprinkler operation

Note; sprinklers too far off teeing surface, only one sprinkler per tee, wasted water off teeing surfaces, insufficient sprinklers on tees etc

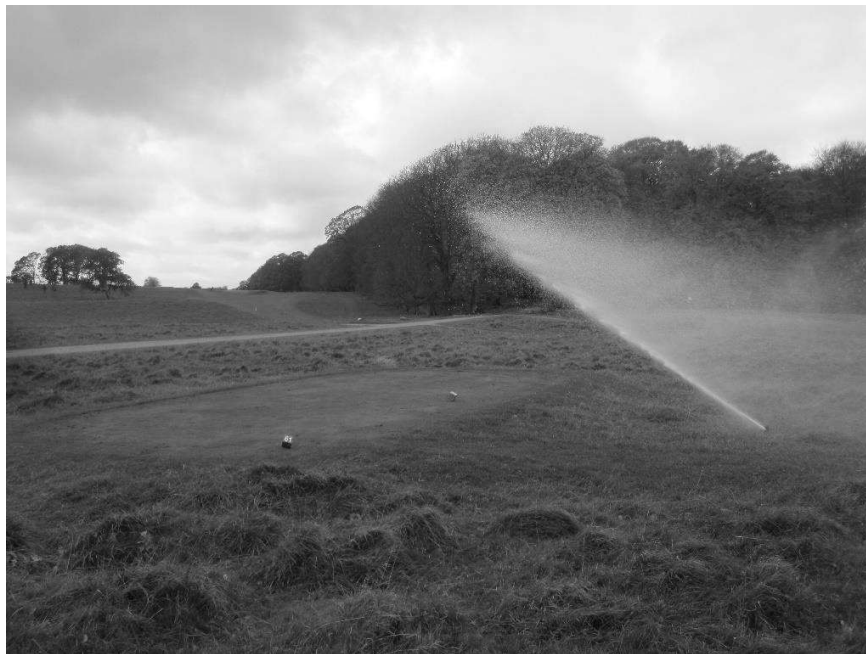
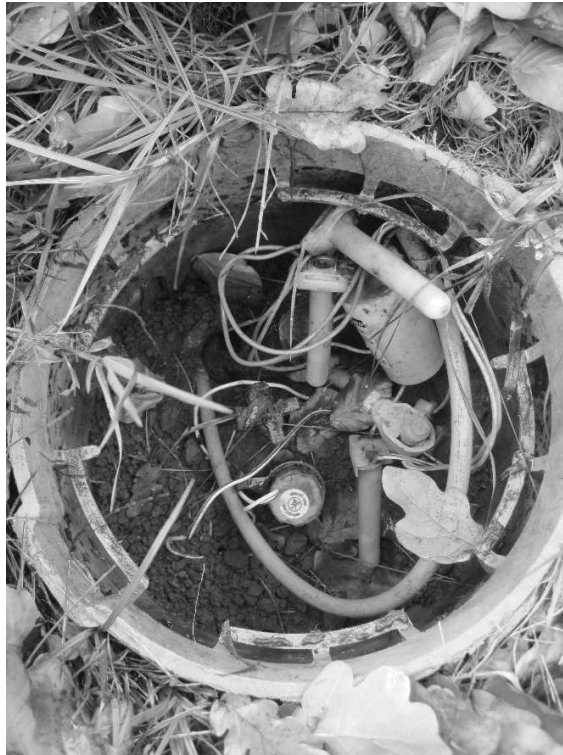
Tee solenoid valves

Note; condition of handles, poor access to components, no isolation valves for servicing,  
no pressure regulation  
(assemblies are certainly showing their 24+ years)

- 2.67** The solenoid valves are not fitted with pressure regulation to ensure that the sprinklers receive an even pressure within the limits of the irrigation design. This is therefore likely to influence the operational pressures of the sprinklers across the course which would cause some tees to receive more water and other less for the same spacing, nozzle and run time. The pressures at tee sprinklers taken during the visit would confirm this as they varied from 4.2 bar to 6.8 bar. There is a need to have pressure regulation fitted to all solenoid valves in the future and it is not known why it was not fitted during the original installation [it may not have been available].

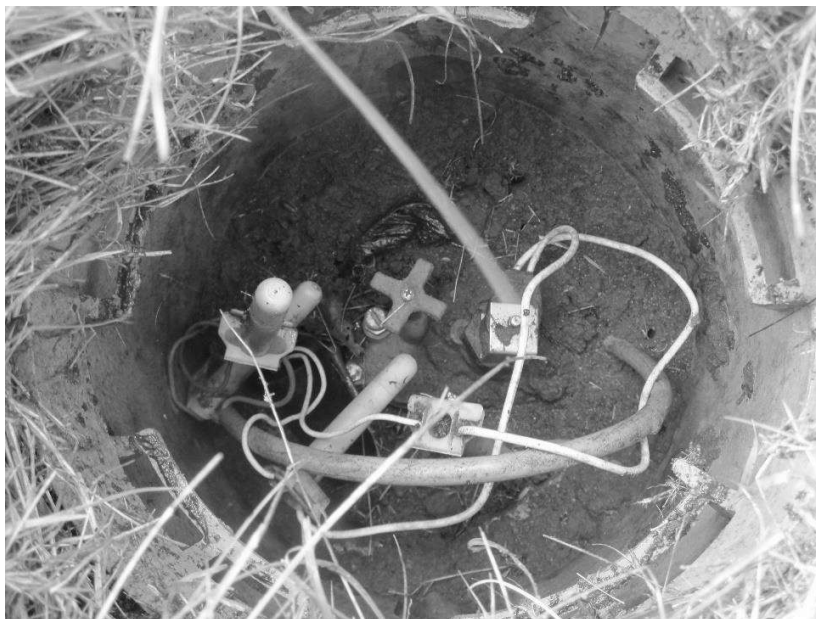
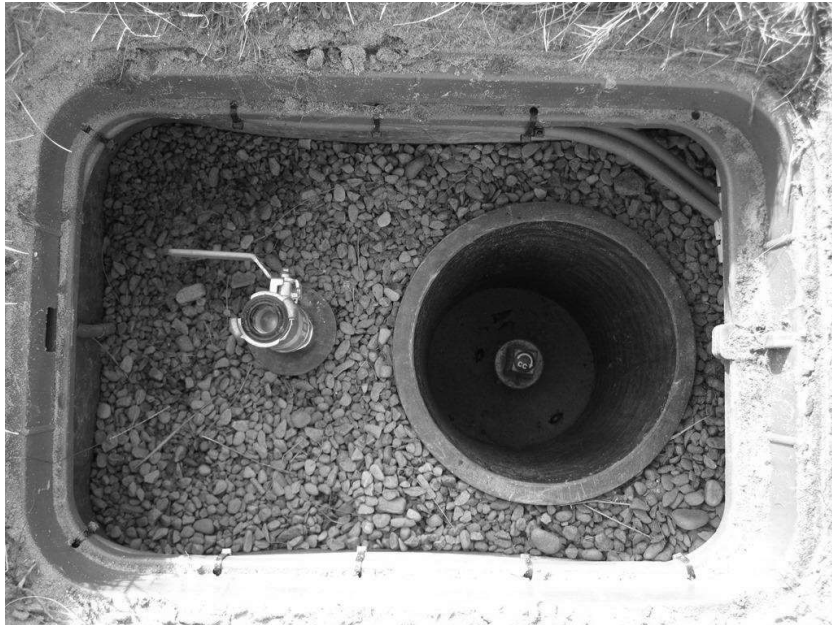
Typical Green isolation valve assembly – 2018 [example photo]

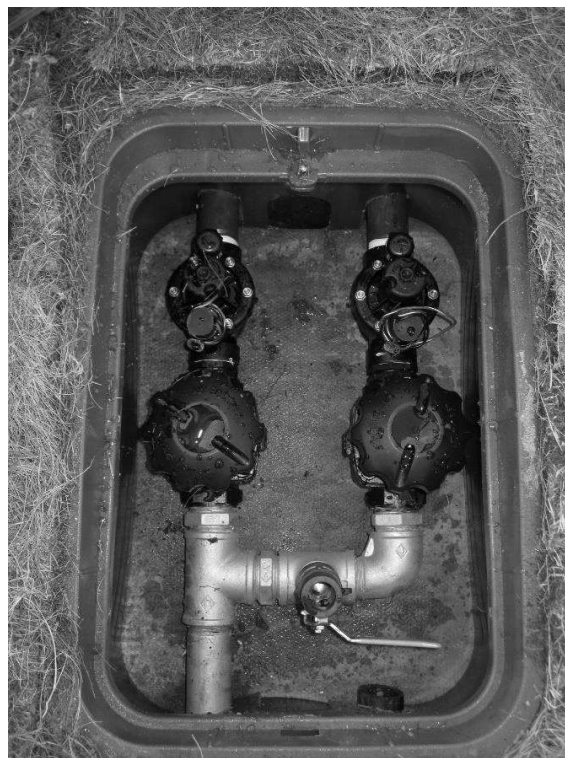
Typical Tee solenoid valve assembly – 2018 [example photo]

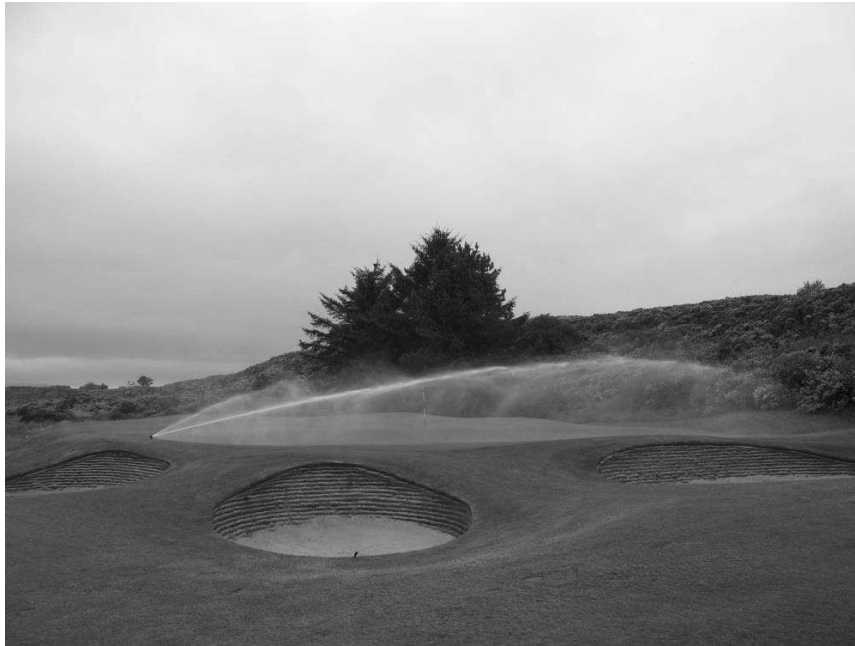
An example of a sprinkler operating at a lower angle

- 2.51** Wind disturbance/drift is a problem on areas of the course. Whilst the sprinkler selection and nozzles installed on many of these greens is suitable for head to head coverage there is a need in windy conditions to either install sprinklers with large nozzles or with a lower angle of trajectory. Using larger nozzles than the sprinkler spacing will provide a greater chance of achieving head to head coverage, however, in some instances this may not be enough and a lower angle of trajectory may be needed too.
